## Pietermaritzburg Integrated Rapid Transport Network Itemised assessment of the Church Street section

**For direct submission to *Amafa aKwaZulu-Natali***

**Phase IV submission:  
Timber Street to Boschhoff Street  
June 2016**

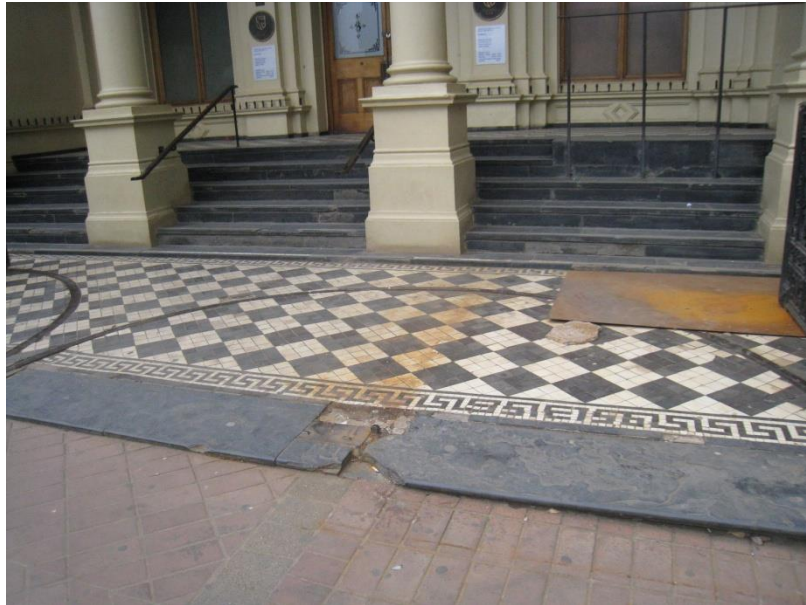
**Fig 4: Showing existing damage to edging of paving and staining of encaustic tiles**

- The work on site must be supervised at all times.
- Given that the time between the documentation exercise in this report and the commencement of work on site can result in further damage to the structure, prior to carrying out work, the contractor must take a thorough, detailed set of dated photographs in order to be able to monitor the works in the event of damage. Particularly, the damaged apron and the staining on the encaustic tiles must be documented.

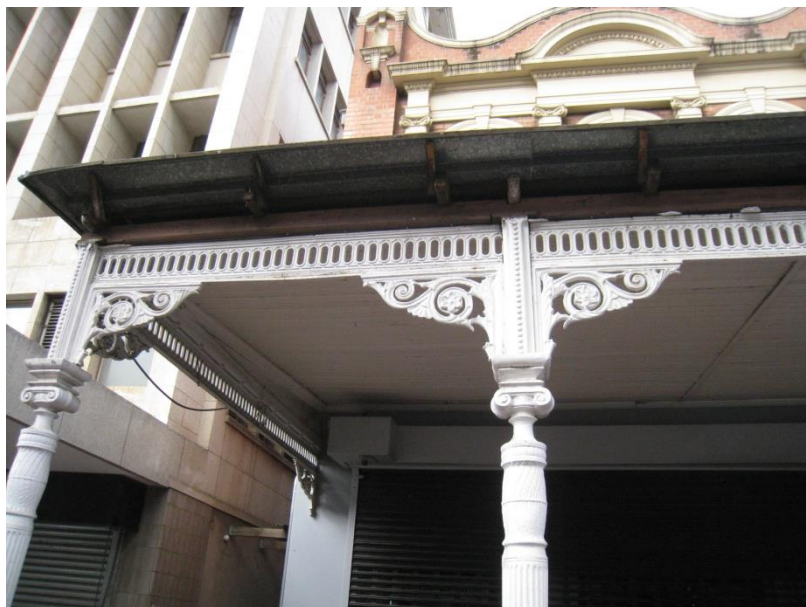
**Fig 42: Showing condition of columns and cast iron brackets but concern about the roofing to the canopy**

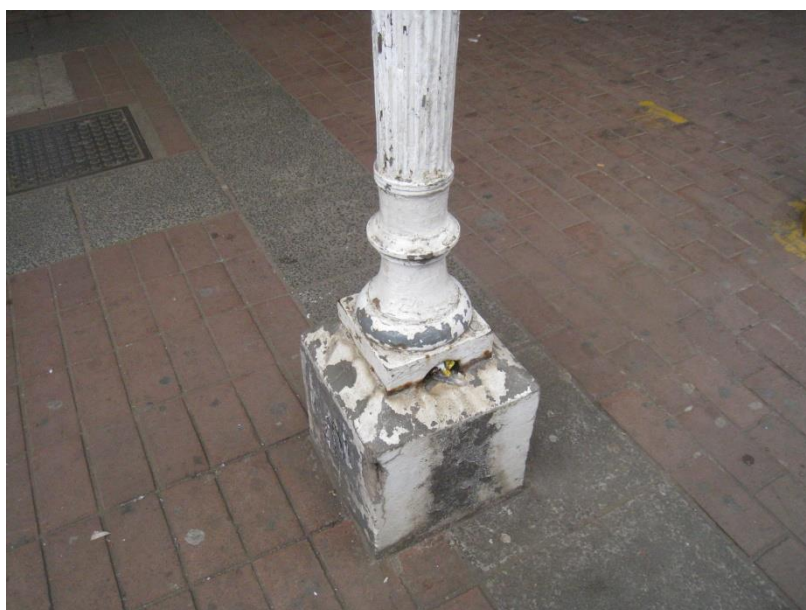
**Fig 44: Condition of column bases**

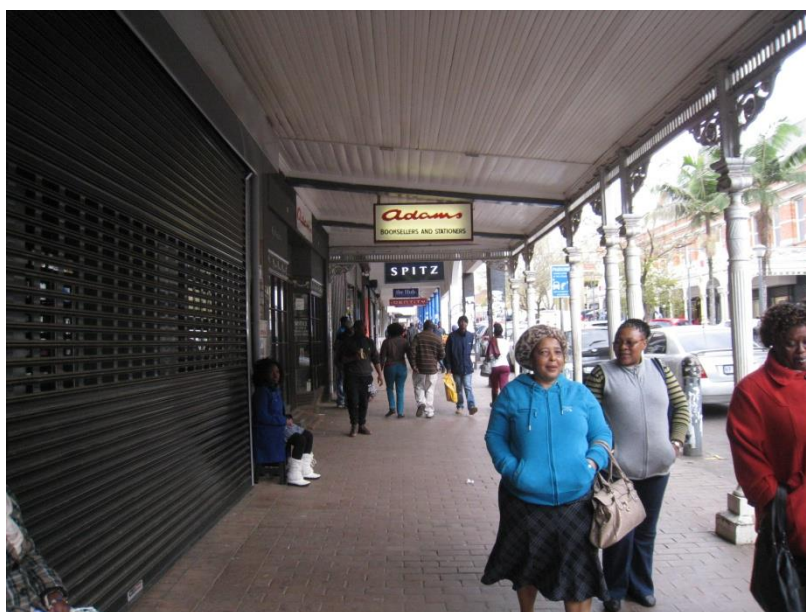
**Fig 46: Showing condition of ceiling under canopy and shopfront – pavement – pedestrianized street interface**

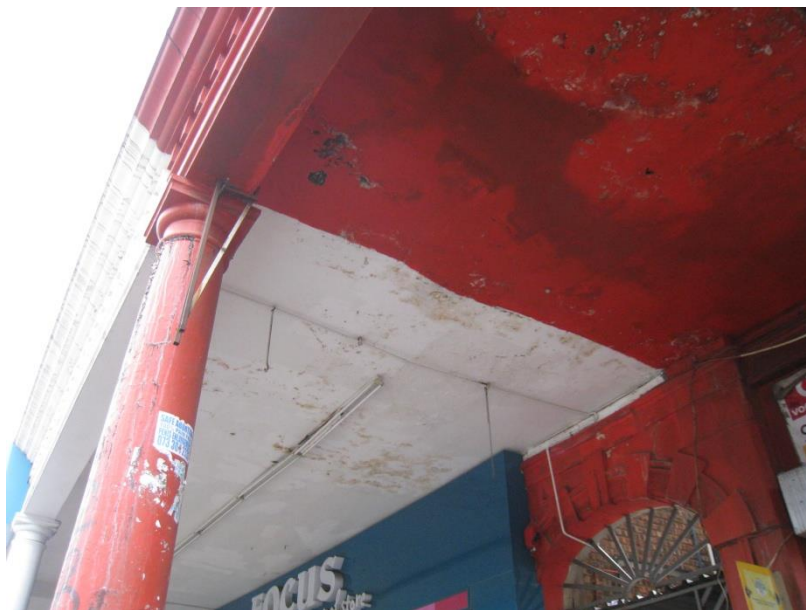
**Fig 68: Damage to the underside of the canopy soffit**

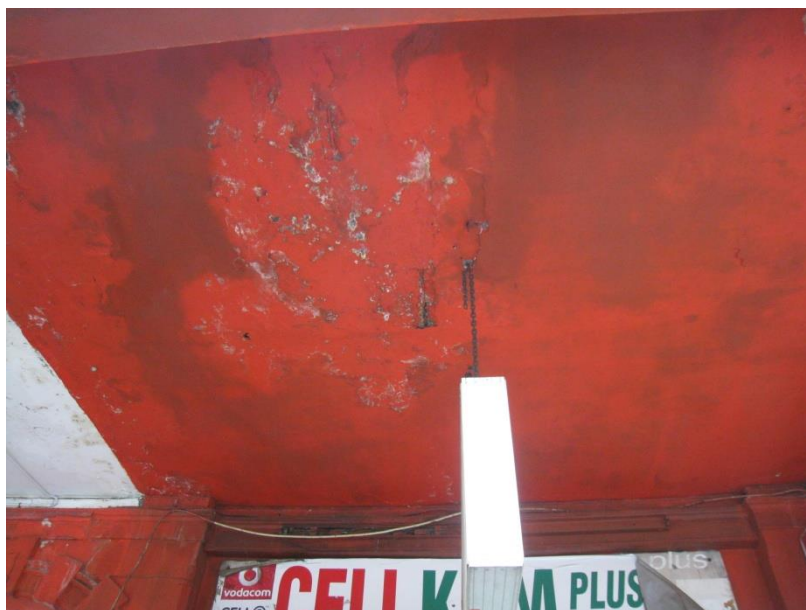
**Fig 69: Damage to the underside of the canopy soffit**

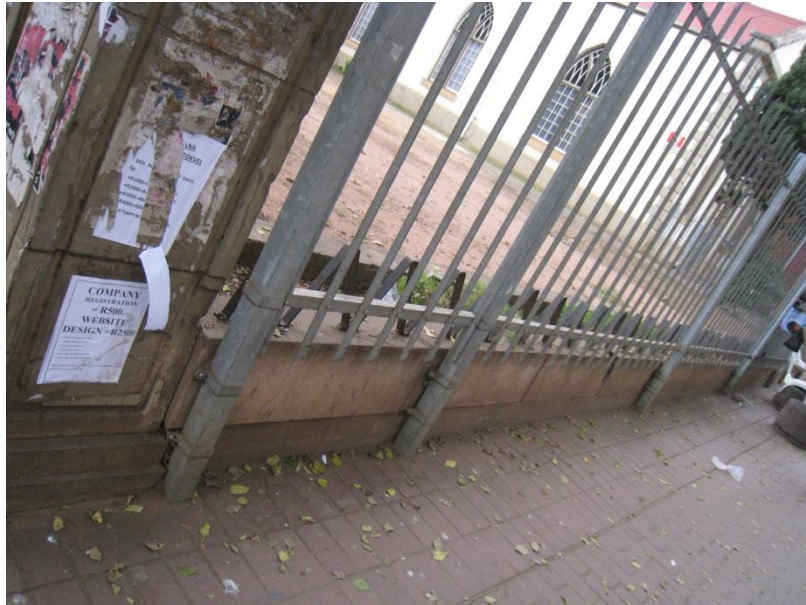
**Fig 73: View looking towards the Old Presbyterian Church with the old wall, the fixings to the wall, the palisade and the wall – pavement interface. Note particularly the damage done to the posts by bill sticking**

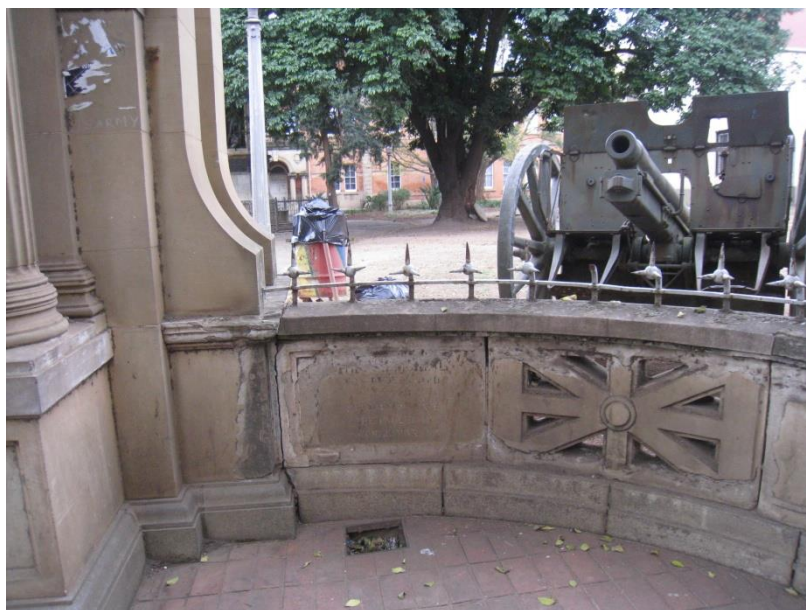
**Fig 74: Damage to the wall through lack of maintenance**

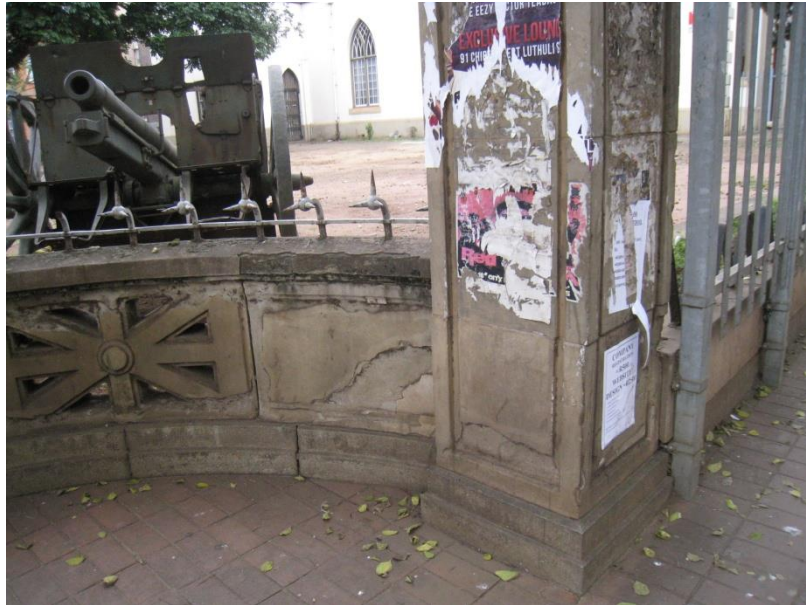
**Fig 75: Damage to the walls through lack of maintenance. Not damage by bill sticking**

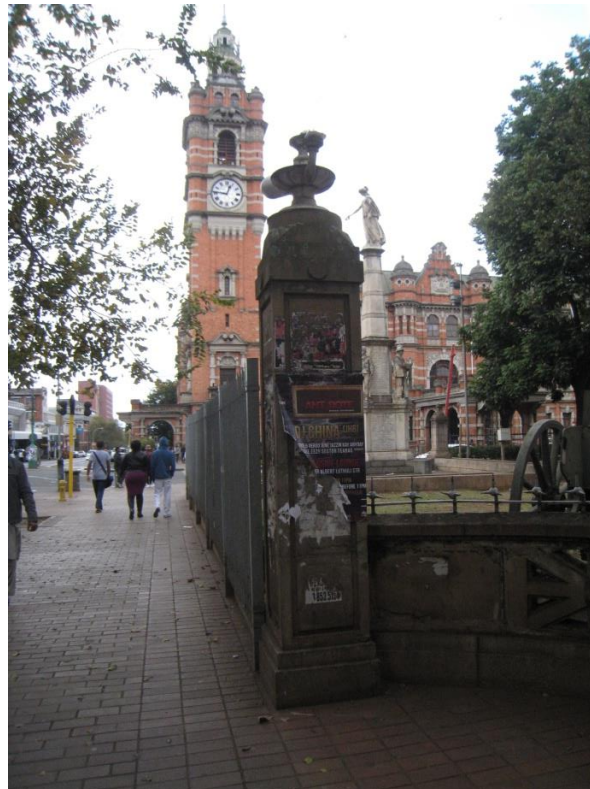
**Fig 76: View along Albert Luthuli Street towards the Tatham Art Gallery. Note damage to stonework from lack of maintenance as well as damage through bill sticking**

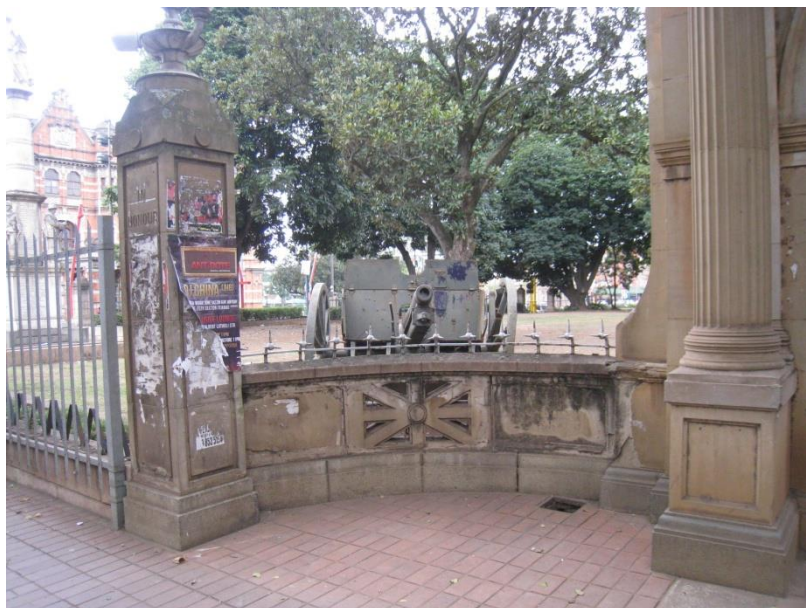
**Fig 77: Note damage through lack of maintenance and also damage through bill sticking**

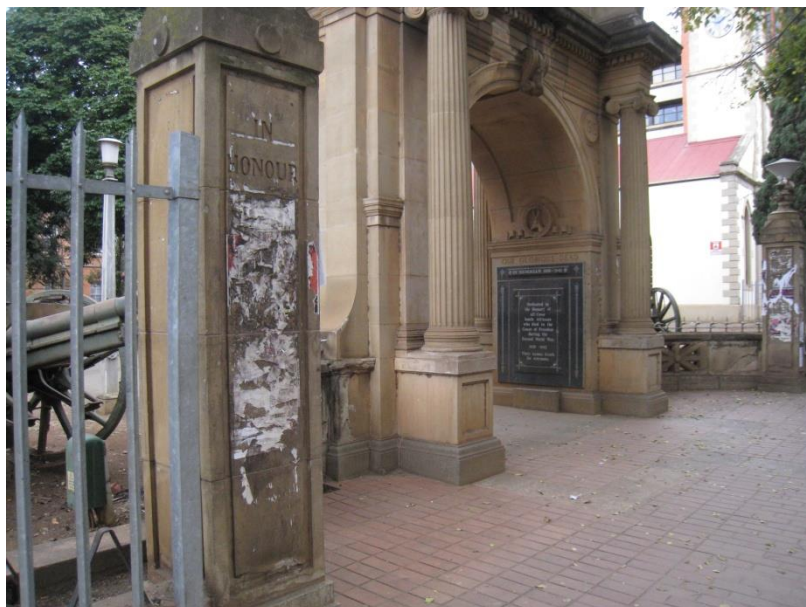
**Fig 78: Irrational placement of palisade and damage through bill sticking**

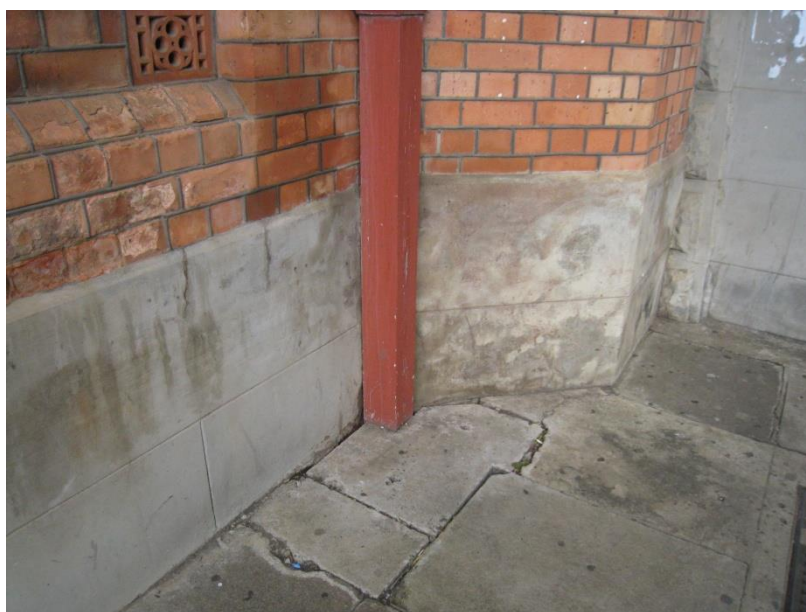
**Fig 86: Degradation of plaster and brickwork, possibly as a result of the downpipe below ground**

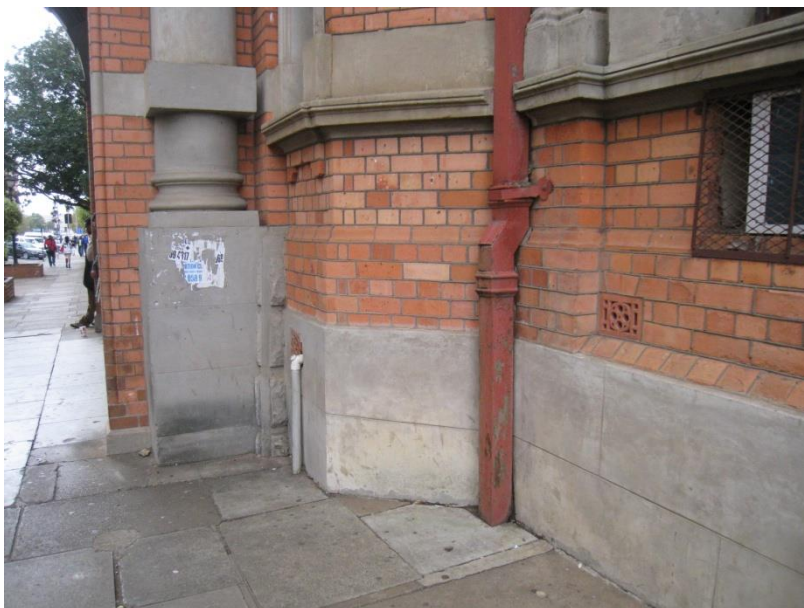
**Fig 87: Condition of plastered plinth at entrance to the City Hall. Note bill stuck to wall**

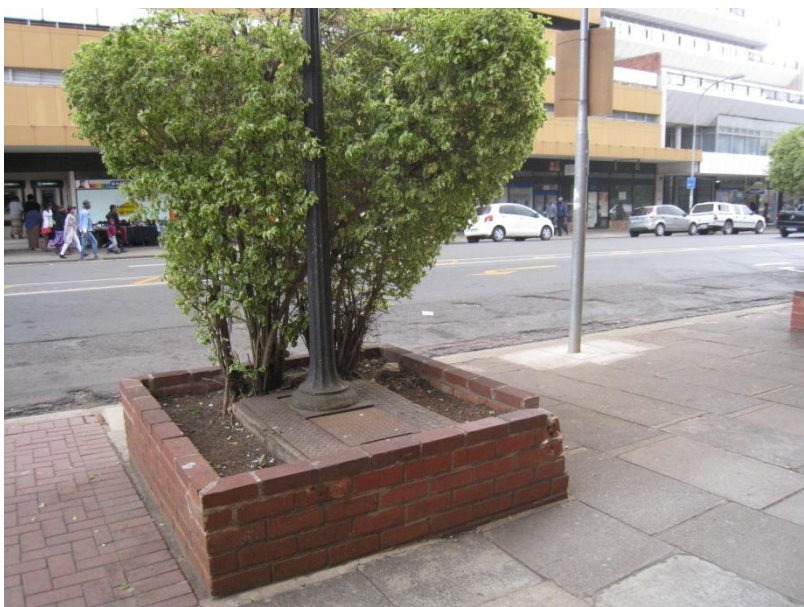
**Fig 88: Lampstand in planter, planter damaged**

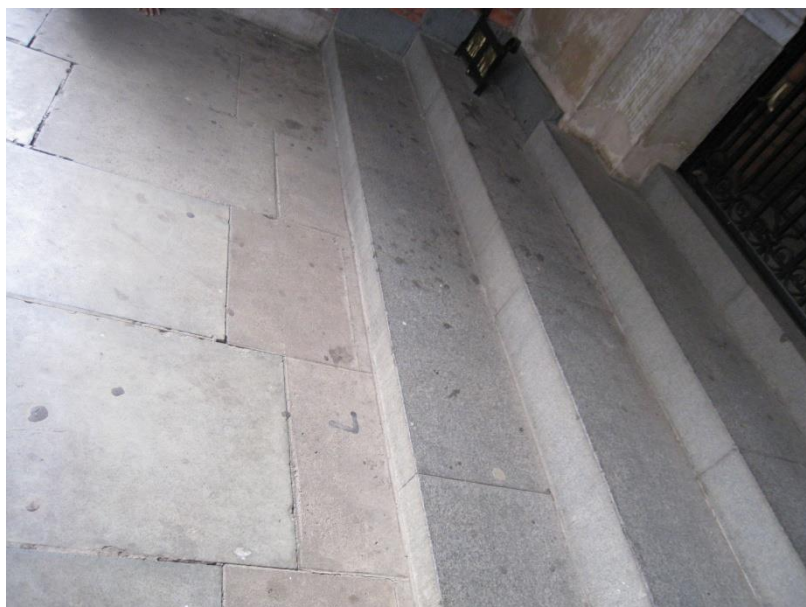
**Fig 90: Showing condition of steps to City Hall**

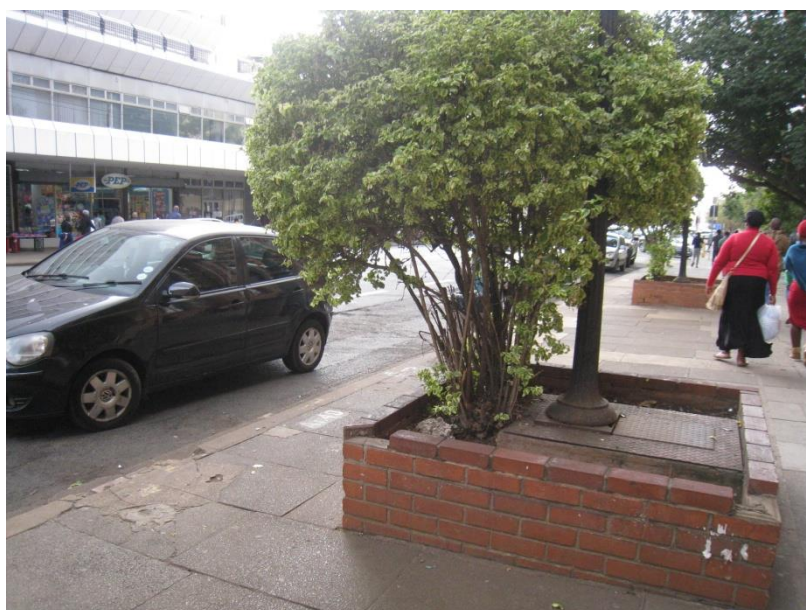
**Fig 92: Planter outside Church Street entrance to City Hall – note damaged brickwork**

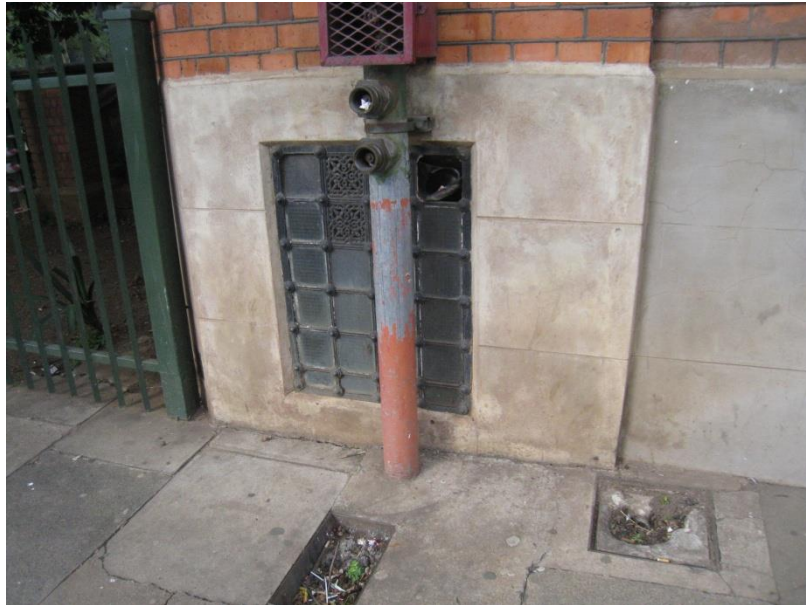
**Fig 93: General lack of repair and maintenance outside City Hall**

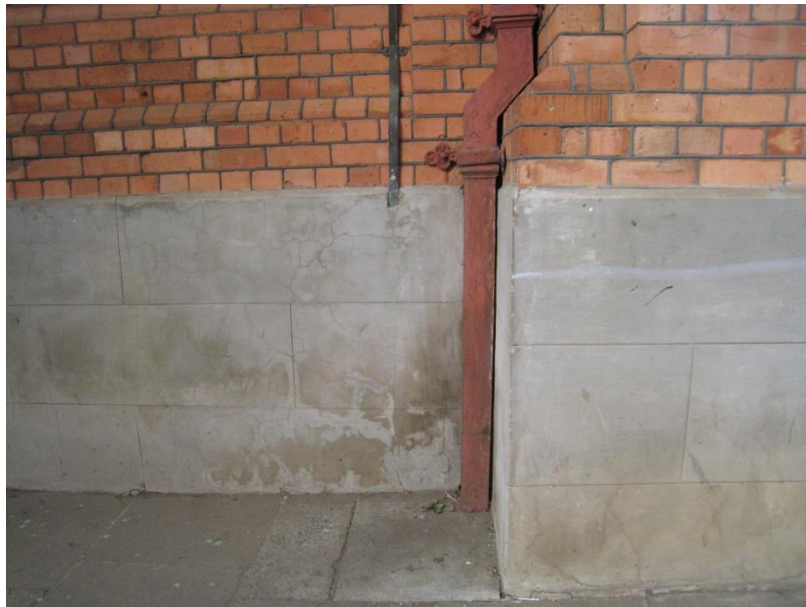
**Fig 95: Condition of wall along Church Street section of the City Hall**

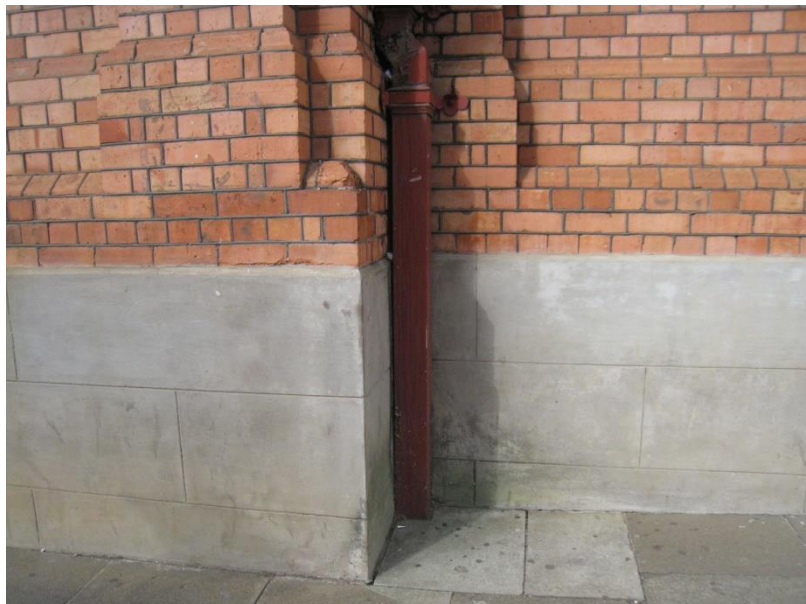
**Fig 96: Condition of walling along the Church Street section of the City Hall**

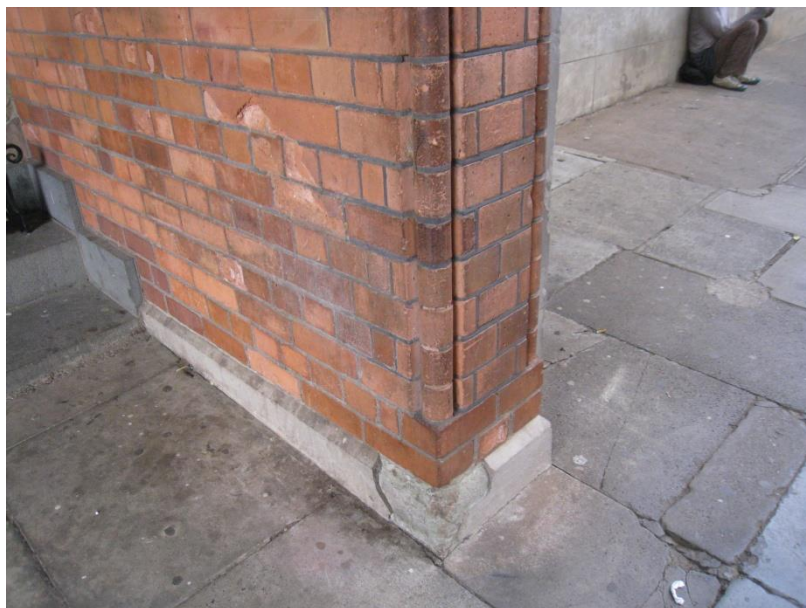
**Fig 97: Note degraded plaster work to base and damaged brickwork in Church Street entrance to the City Hall**

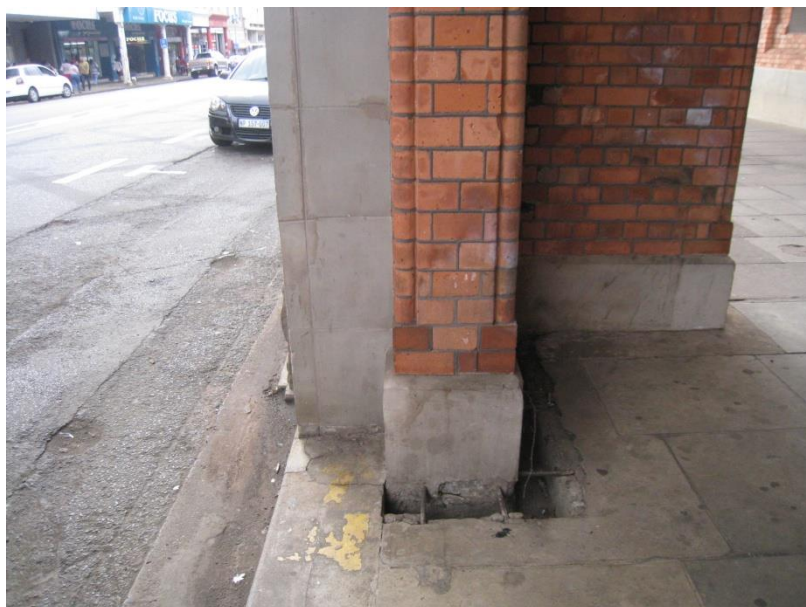
**Fig 98: Showing cursory treatment of areas around Church Street entrance to the City Hall**

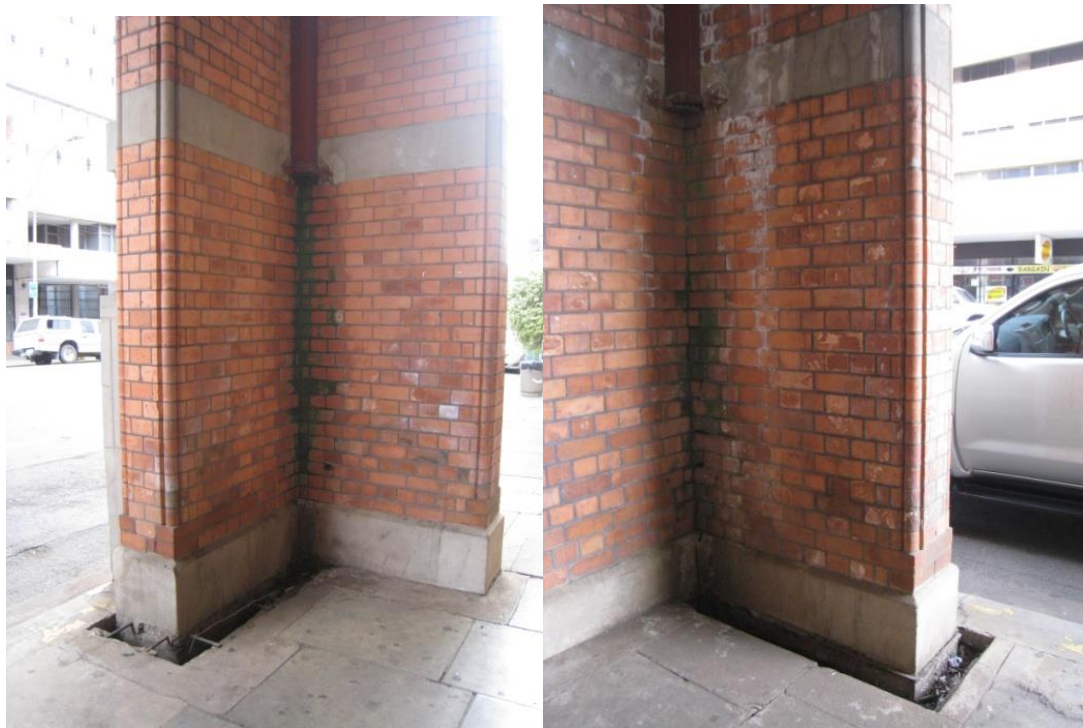
***Figs 99 & 100: Damage to both inner corners from downpipes not being replaced***

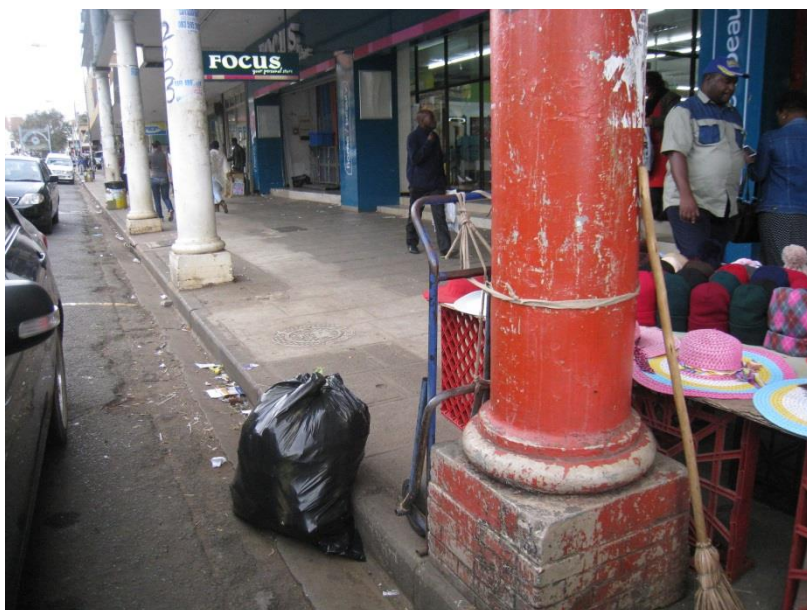
**Fig 111: Showing condition of colonnade created by buildings 279 – 283 Church Street**

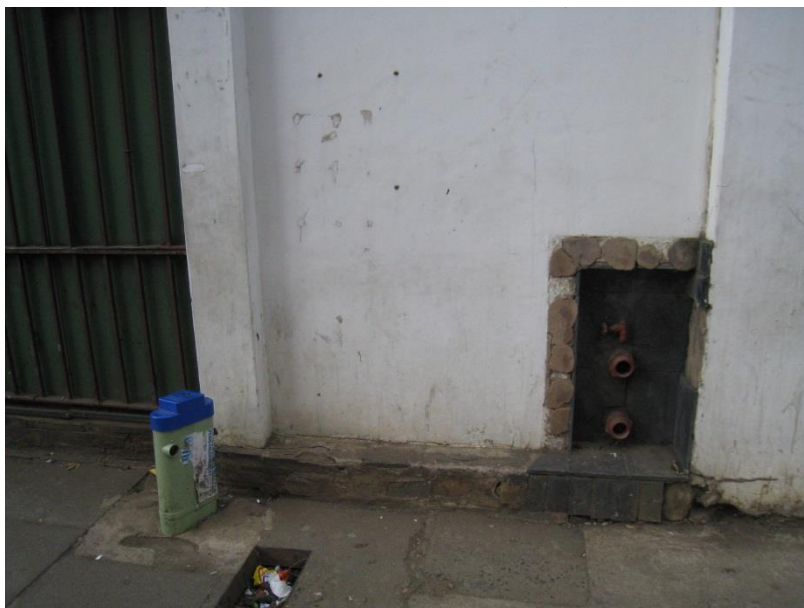
**Fig 130: Church of the Vow services on the street and damaged pavement**

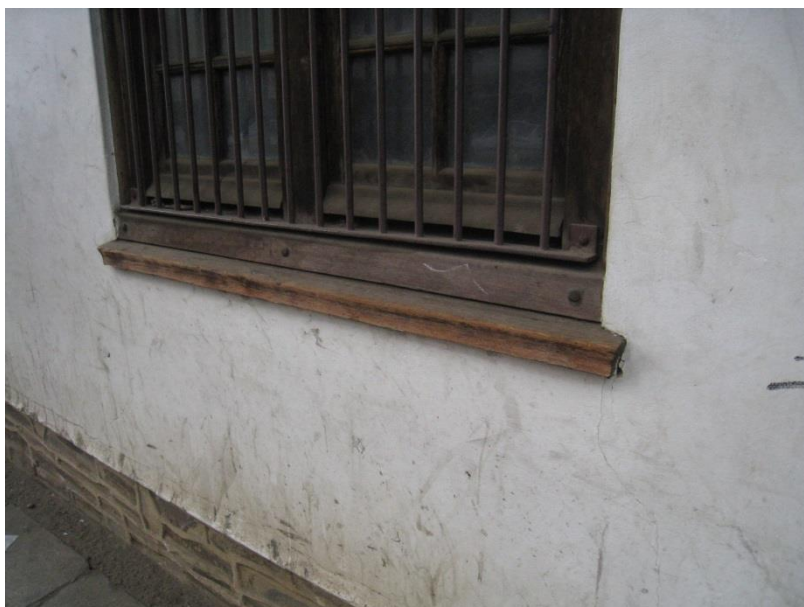
**Fig 131: Showing building – pavement interface. Condition of window cills good**

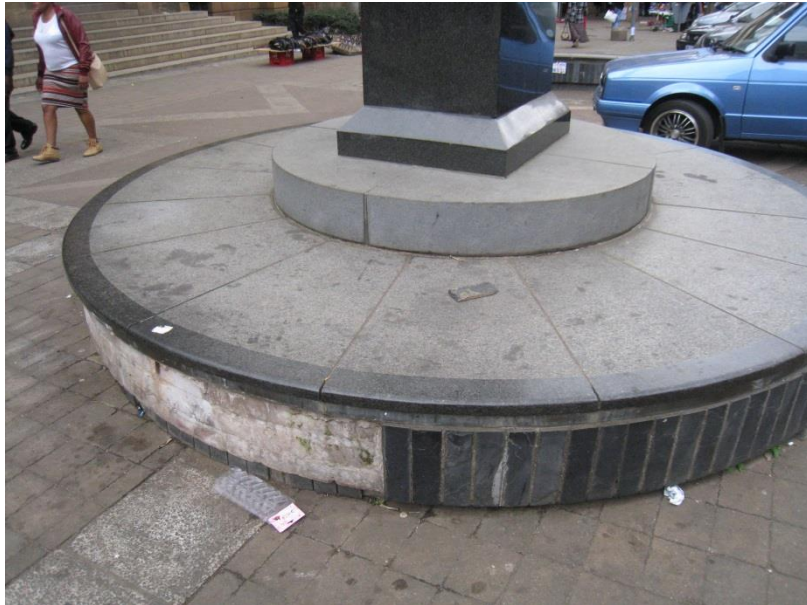
**Fig 134: Base of the statue of Gandhi – note spalling tiles**

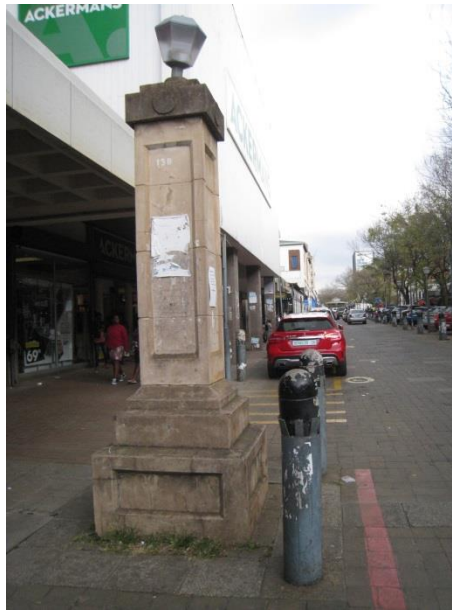
**Fig 137: Bollard showing plaster spalling from base**

**Fig 138: Bollard as in Fig 137**

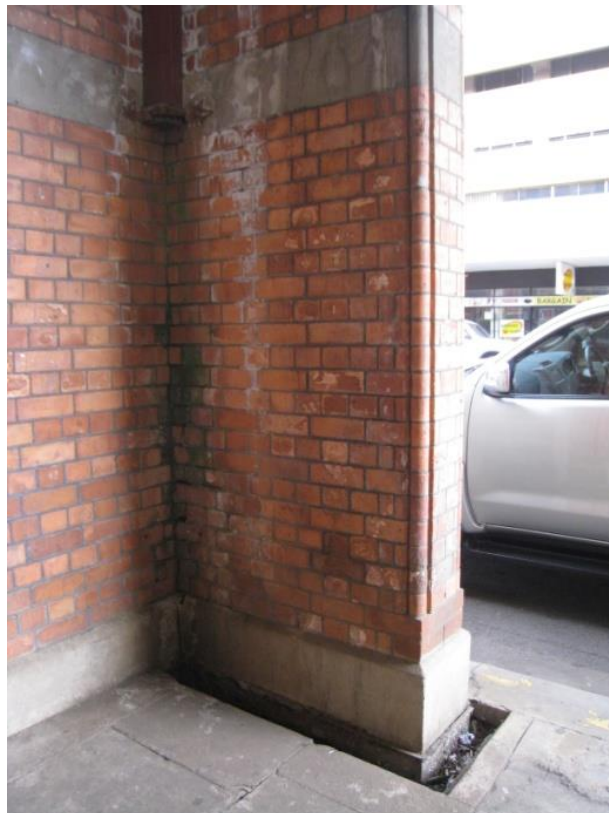
*Fig 140: Lack of maintenance on the guttering system, City Hall*

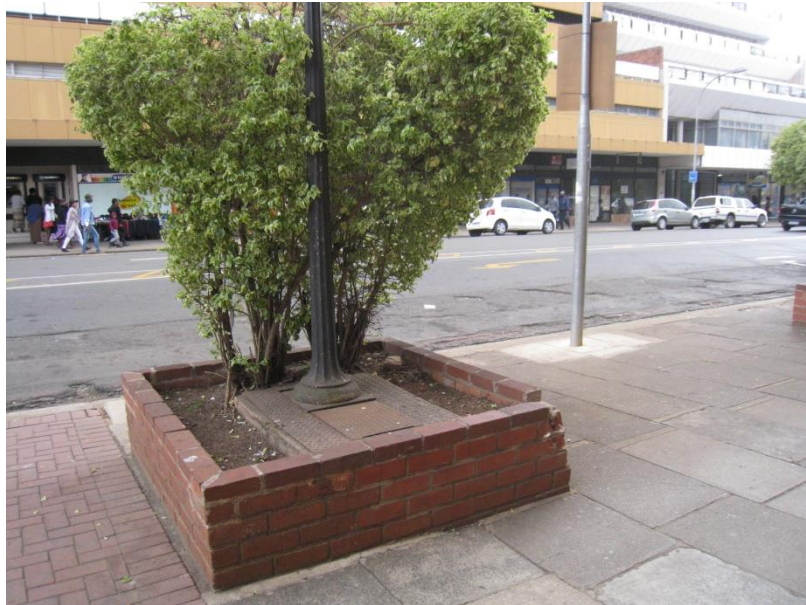
**Fig 141: Damaged planter outside the City Hall**

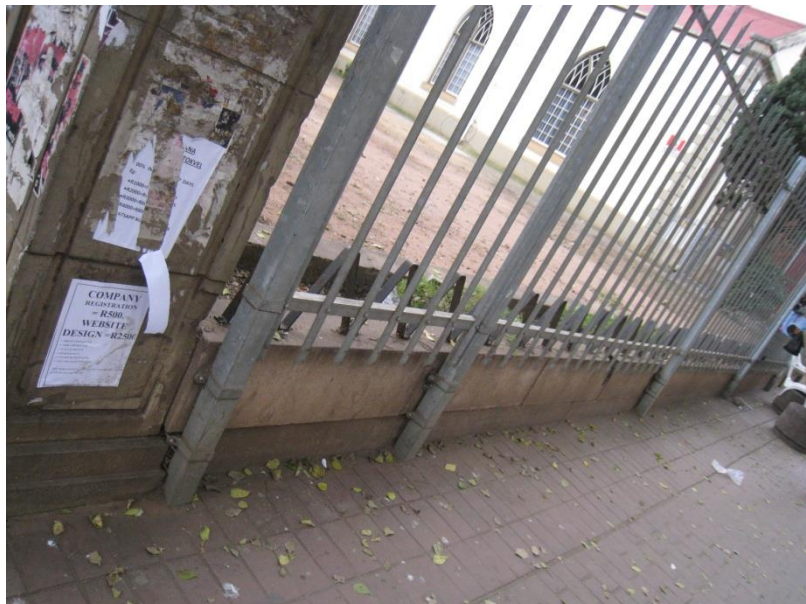
**Fig 142: Perpetual bill sticking on City property**
